CASE HISTORY Ref: USA0028—Rev:01, Issue Date 14.12.2004

DURABLE GABION RETAINING STRUCTURE

FALLS ROAD, BALTIMORE, MD, USA

RIVER BANK PROTECTION **Product:** Gabions

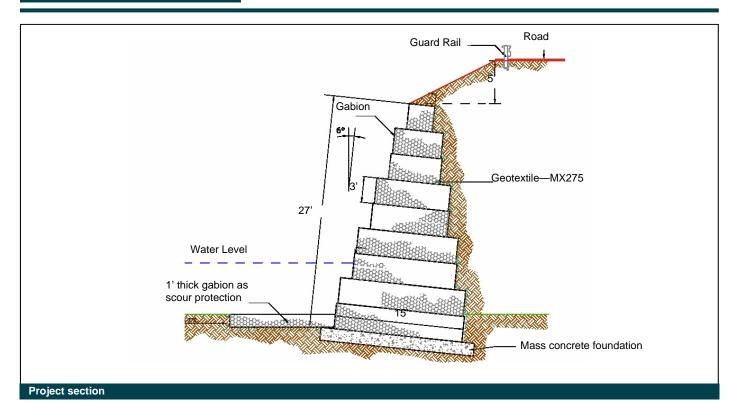
Road way drain pipes were punched through the face of the gabion wall to outfall into the watercourse. The woven gabions were easily shaped on-site to accommodate these pipes.

Gabion units were installed as an anti-scour 'apron' at the toe of the retaining wall to prevent erosion undermining the wall.

In 2004, 30 years later, Maccaferri revisited the gabion retaining wall. Samples of the PVC coated mesh were taken. Laboratory tests were carried out on the zinc coating left on the steel under the PVC, and the residual properties of the PVC after 30 years of UV and abrasion exposure.

The results were excellent. Only 35% of the initial properties of the PVC had been lost, and the amount of zinc remaining was still superior to the minimum requirement of the project specification. By comparing the 35% loss in PVC properties to recent reference results from accelerated heat aging laboratory tests, the structure has a life expectancy of around 60 years. (See Maccaferri TECHNICAL NOTE – GABION DURABILTY for more detailed information.)
